# Soil Nailing Practice in İstanbul

C. Güney Olgun

Prof. Dr. H. Turan Durgunoğlu

Boğaziçi University, Civil Engineering Department, İstanbul, Turkey.

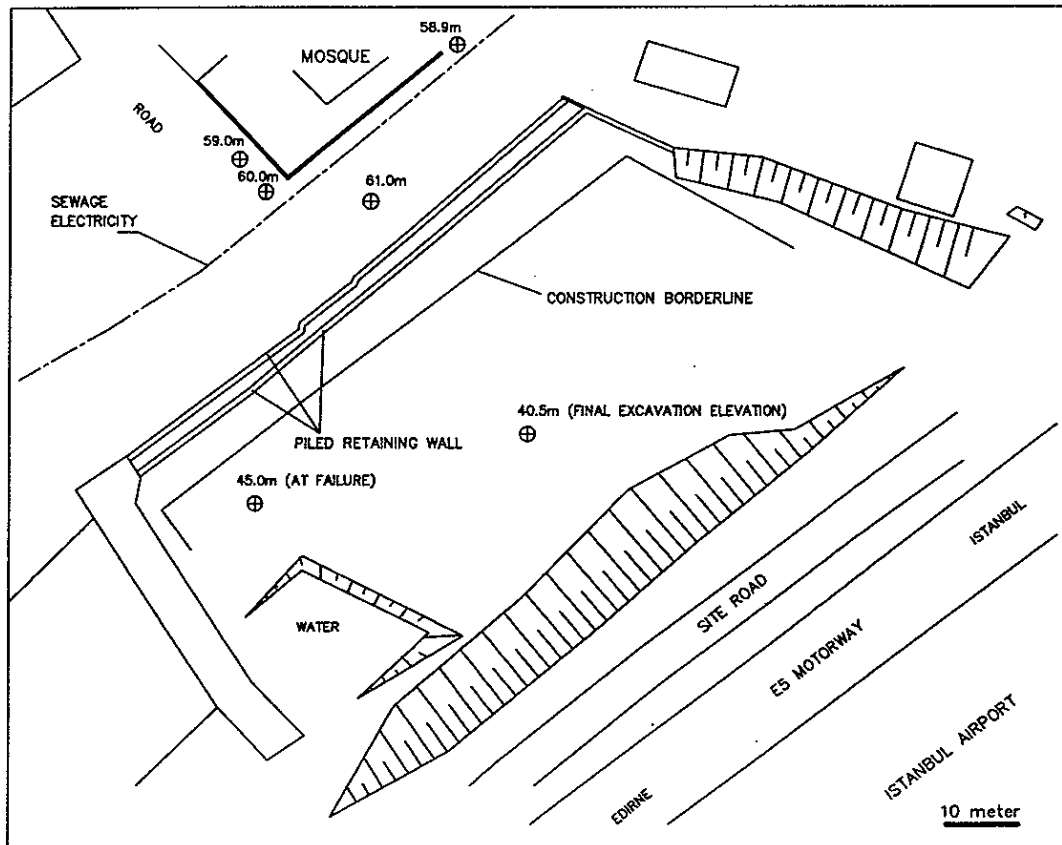
Figure 1. Site Plan

A sudden failure has occurred in a tieback retaining wall during the deep excavation of a high rise hotel building in İstanbul. The depth of the excavation base is planned to be 20.5m, whereas the failure took place when the excavation was at 16.0m depth. The plan of the failed retaining system is shown in Figure 1. The sliding block covered the entire wall with a length of 80 meters, the main scarp extending to 15 meters behind the wall.

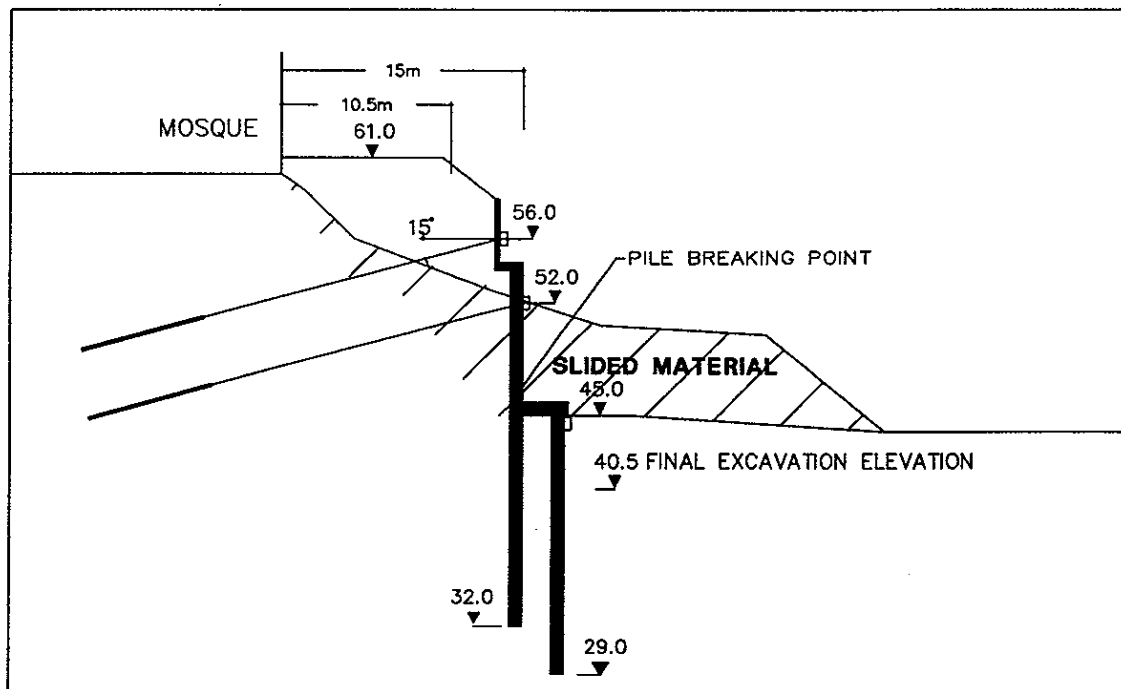
Figure 2. Typical Cross Section of Tieback Retaining Wall and Failure Geometry

The tieback wall was designed as the retaining system for the foundation excavation of a high rise hotel building. The retaining system consists of intersecting bored piles of  $\phi$  80 cm diameter, tied back with two rows of 20.0m long anchors. The initial ground elevation prior to excavation is 61.0m and the elevation of the final excavation base is 40.5m, creating a depth of 20.5m. A typical cross section and failure geometry is shown in Figure 2.

A sudden failure has occurred in the system described above when the excavation was at elevation 45.0m, corresponding to 16.0m depth. The failure covered the entire wall length of 80 meters, extending to 15.0m behind the wall. All of the anchors supporting the piled wall have shown to fail, some pulled out from the soil, some broken by the tendons. Resulting in damage to some neighboring structures and breaking sewage pipes and electricity cables, whole material in this zone slid into the excavation area.

The forces expected to develop on the elements of the tieback wall have been investigated by performing a back analysis on a typical cross section, using the available parameters. The backcalculated forces have been evaluated by comparing the forces expected to develop on the retaining wall with maximum capacities. Possible scenarios of failure have been checked to determine the failure mechanism. The results of the analyses are summarized below in Table II.

It has been determined from the performed analyses that, even though the geotechnical parameters used in the design were valid, forces exceeding the allowable capacity are expected to develop on the elements of the tieback wall. Finally it has been determined that the intrusion of water and decomposition resulted an initial sliding movement. With this initializing movement, the shear strength of overconsolidated clay dropped from peak values to residual values and the stresses in the anchors increased to values exceeding the maximum capacity, resulting with failure (Durgunoğlu, 1995).

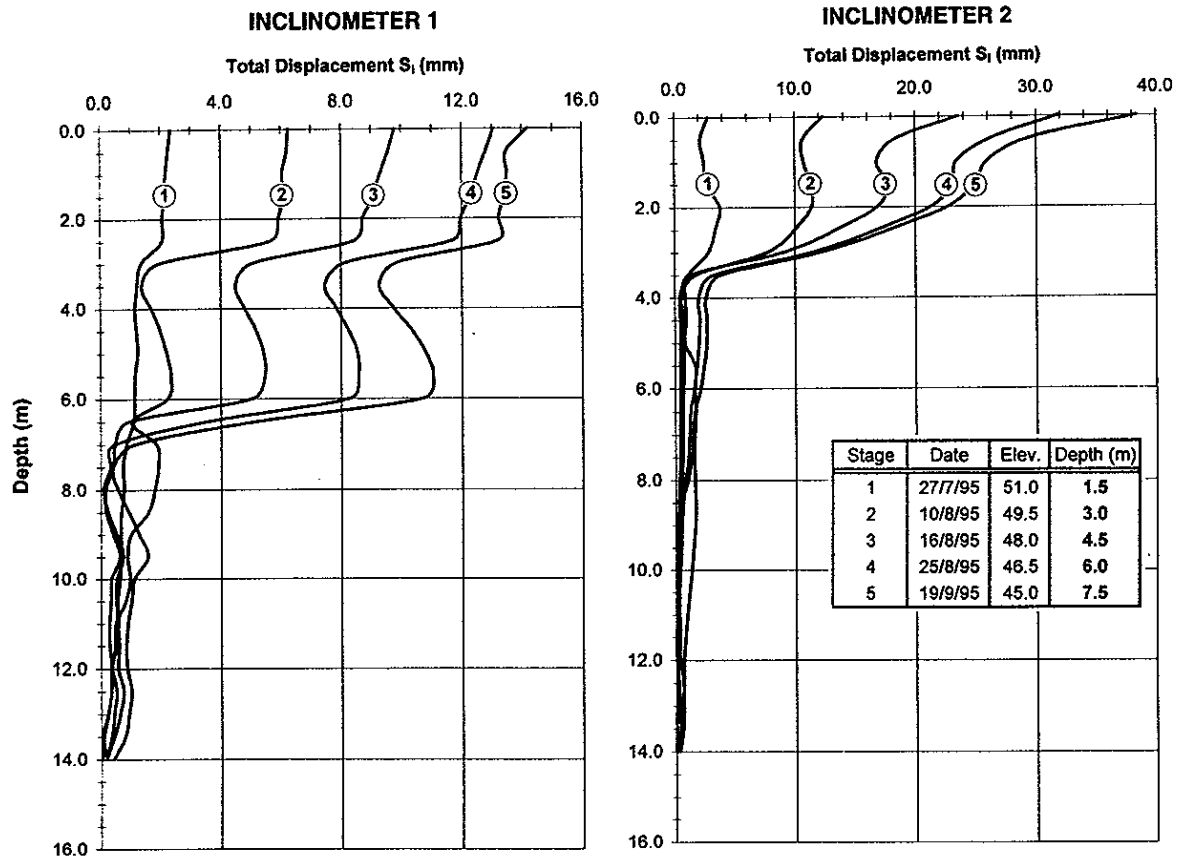
Figure 5. Monitoring Results

It was determined from the performed analyses that the shear strength parameters of the subsoil had dropped to residual values due to sliding. The deformations during the excavation were expected to rise to values critical for neighboring structures, due to the presence of a preslided surface and the drop in soil shear strength. Two inclinometers were installed at 52.5m elevation at the berm of the nailed wall to monitor the lateral movements during excavation. The location of the inclinometers along the wall are shown in the plan showing soil nailing application. The second stage of the nailed wall that has been monitored is completed in five excavation stages. The lateral deflections measured with two inclinometers for each excavation step are shown in Figure 5.

Several sliding surfaces have been detected during the excavation and construction processes. It is seen from both inclinometer readings that, sliding has started 3.0-3.5m below the berm at the first excavation stage, but this movement has stopped at location of inclinometer 1, in the proceeding excavation steps. In the following excavation stages, a surface located at 7.0 m depth has started to move at location of inclinometer 1. The deflections at inclinometer 2 location have continued to increase at depth 3.5 m to values measured larger than the first inclinometer. The measured deflections have shown to be in good agreement with the sliding surfaces proposed in the design procedure of the nailed wall.
