## Flexible Earth Retaining Structures - Soil Nailing

H. T. Durgunoğlu\*, H. F. Kulaç\*\* and C. G. Olgun\*

## FOUNDATION PROBLEMS OF KONYA ALAEDDIN MOSQUE AND IMPLICATION OF REMEDIAL MEASURES

H.T. Durgunoğlu(1), T. Karadayılar(2), C. G. Olgun(1)  
(1) Boğaziçi University, Civil Engineering Department, İstanbul, Turkey  
(2) Zetas, Earth Technology Corp., İstanbul, Turkey

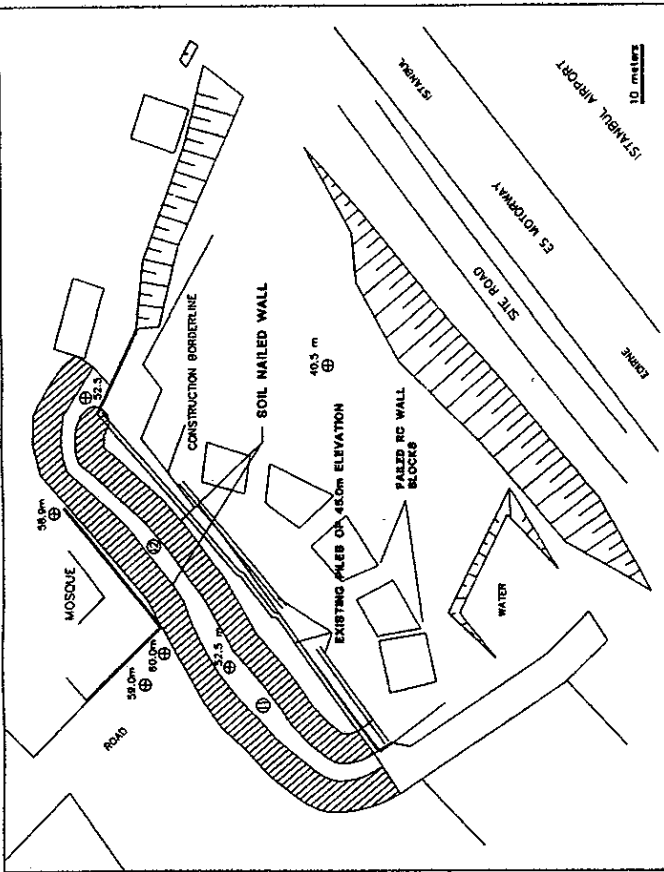
Figure 3. Plan of the Soil Nailed Retaining System

After the studies performed to determine the failure mechanism and with the evaluations of the geometrical configuration of the slide, a soil nailed wall starting behind the sided slope as seen in Figure 3, has been designed for remediation works. The nailed wall consists of two stages extending from elevation 45.0m to 60.0m. The nails are located with 2.0m horizontal spacings. The final excavation depth which is below the base of the nailed wall is designed to be achieved by using the unbroken piles remaining from the initial project.

Stability analyses have been performed both for the nailed wall and overall deep sliding. The optimum nail length is determined with the evaluation of possible slip surfaces along the wall. Two critical sliding surfaces have been checked using the residual parameters assuming no cohesion in residual condition. One of these surfaces is the shallow sliding surface intersecting the toe of the slope. The nail lengths have been optimized with the evaluation of this surface. Alternatively the deep sliding surface passing under the piles has been checked and it has been determined that it was not critical in terms of static and earthquake conditions.

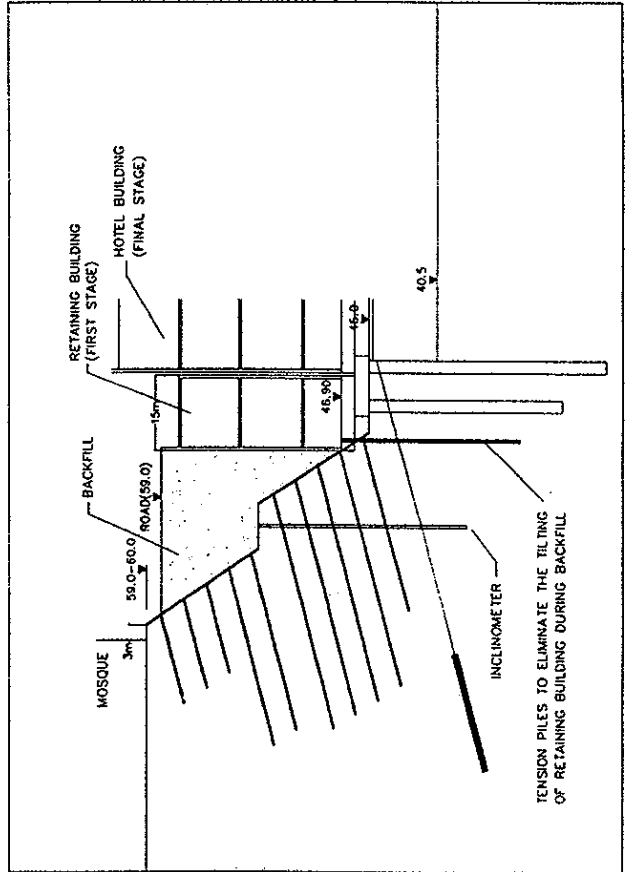
Figure 4. Cross Section of the Building after Remediation

The building construction started following the completion of the excavation supported by soil nailing. At the first stage, the part of the hotel building 5.0m wide has been constructed to enable the excavation area to be backfilled so that the neighboring road could be opened to traffic. The top of the piled wall has been tied back with additional anchors to withstand the overturning moments due to the backfill. Moreover, micro piles of  $\phi$  15cm diameter and 20.0m length with 1.0m spacing have been installed to the base of this 5.0m wide building section to support the building for the overturning moments, as shown in Figure 4.

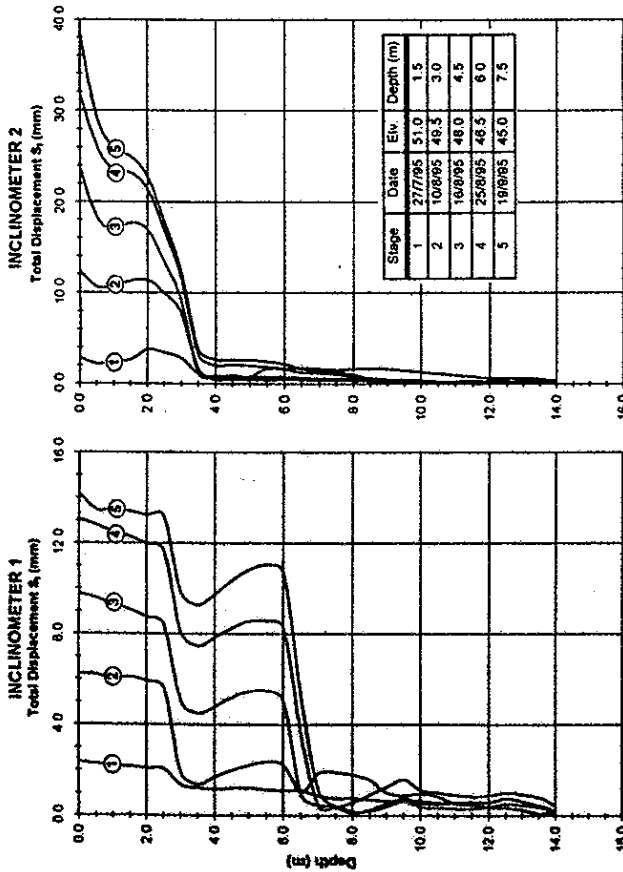
Figure 5. Lateral Displacements Measured During Excavation

Several sliding surfaces have been detected during the excavation and construction processes. It is seen from both inclinometer readings that, movement has started 3.0-3.5m below the berm at the first excavation stage, but this movement has stopped at location of inclinometer 1, in the preceding excavation steps. In the following excavation stages, a surface located at 7.0 m depth has started to move at location of inclinometer 1. The deflections at inclinometer 2 location have continued to increase at depth 3.5 m to values measured larger than the first inclinometer. The measured lateral displacements have shown to be in good agreement with the sliding surfaces proposed in the design procedure of the nailed wall.

The ratio of lateral displacements measured during excavations to corresponding wall heights are summarized in Table 5. The lateral displacements measured are in ranges between 0.2 to 0.5 percent of wall height. These values are in good agreement with the ones proposed in the literature (Elias and Juran, 1989) for deflections required for full mobilization of nail forces and measurements at recent soil nailing applications in İstanbul (Özsoy, 1996).

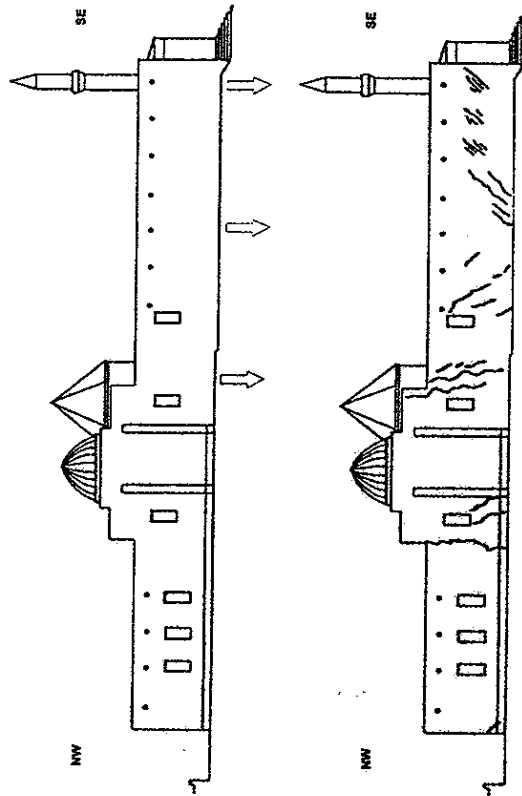
Figure 2. Settlement mechanism and resulting crack pattern along SW-NE wall

It has been determined from the evaluation of performed subsoil investigations and study of crack locations that the foundation of the structure has been subjected to differential settlements. The foundation subsoil has been observed to be highly decomposed due to leakage from the water reservoir located below the southern face and eastern corner of the mosque, which has been used for long years as municipal water storage. Finite element analysis has been performed to evaluate and model the deformation pattern expected to occur within the subsoil located below the mosque. The settlement mechanism and the resulting crack pattern along the northwest-southeast wall are shown in Figure 2.

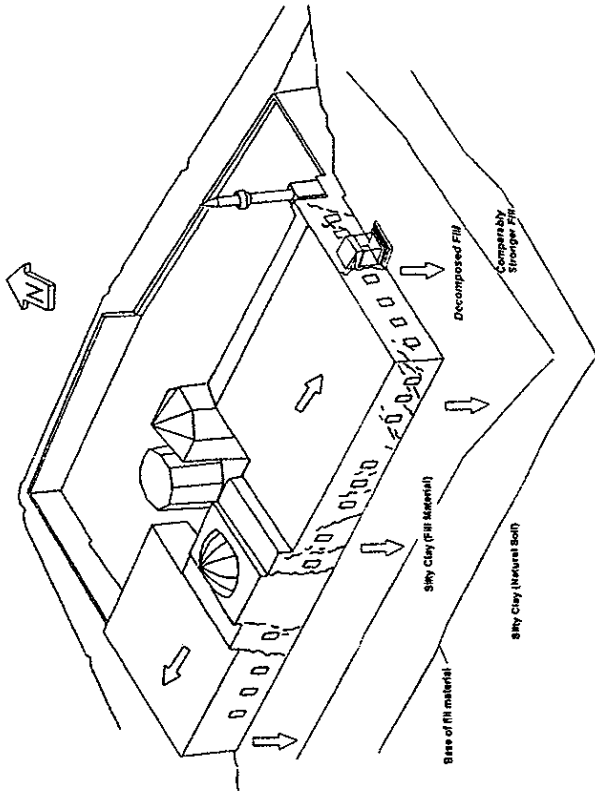
Figure 3. Schematic representation of three dimensional deformation pattern

It has been determined from overall slope stability analyses, no stability problems or lateral deformations are expected to occur at the Alacddin Hill where the mosque is located. However the cracks in the structural elements have revealed that the mosque has been subjected to lateral deformations. The mechanism could be explained in a way that the vertical deformations in the foundation subsoil have

resulted in lateral deformations in the structure due to the behavior of the structural system. In one of the remediation attempts in the past the altar has been connected with tie beams and the roof at these locations has been replaced with reinforced concrete slab. This solution has prevented a possible local failure of the structure and however at the same time it has led the problem to spread to other sections/parts of the mosque. This situation has changed the behavior of the structure drastically. Due to the connections made along structural elements differential settlements in the foundation have resulted in lateral deformations in the structure. A schematic representation of the three dimensional deformation pattern is given in Figure 3.

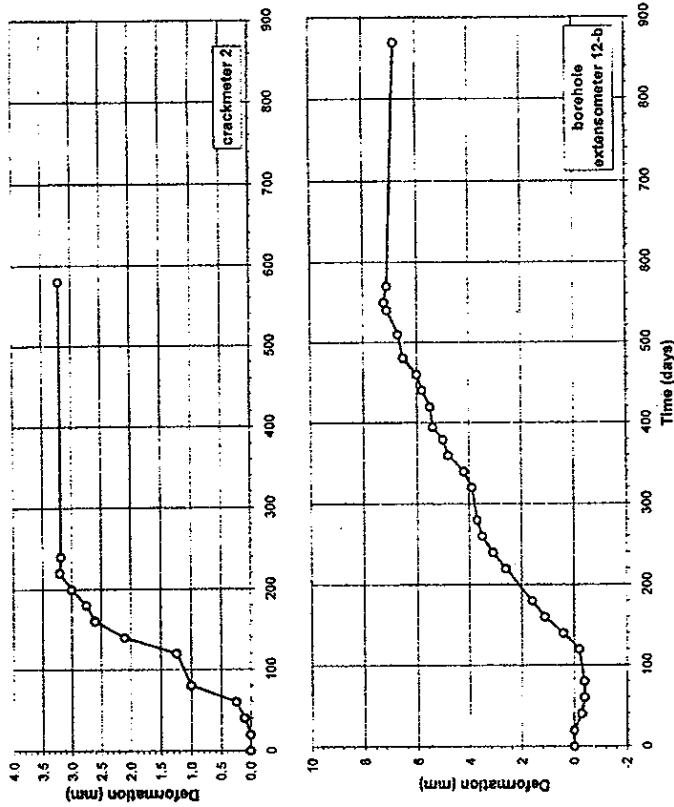
Figure 4. Deformation measurements from crackmeter and borehole extensometer

Deformation data obtained from a crackmeter and a borehole extensometer are given in Figure 4. The deformations observed both by crackmeters and extensometers are observed to diminish within time with the implementation of remediation works.

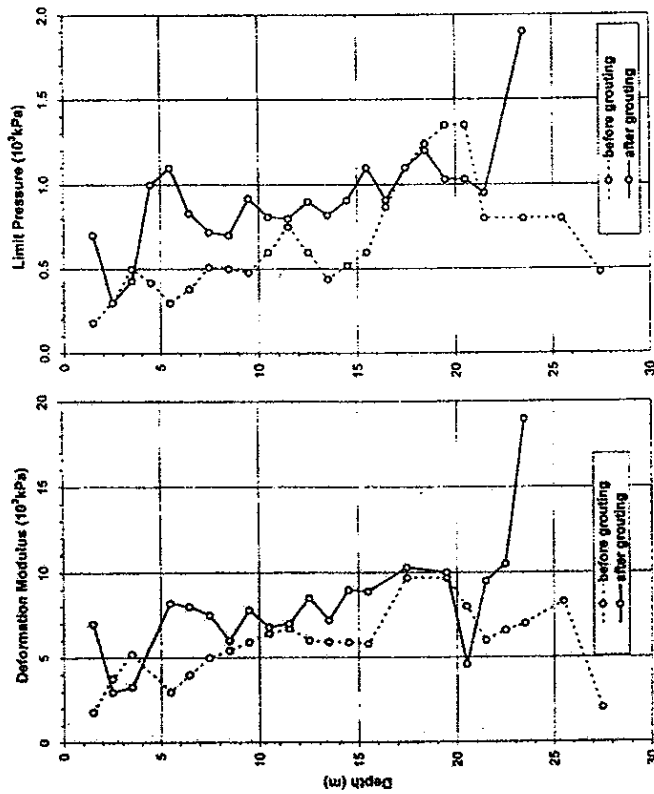
Figure 5. Assessment of degree of soil improvement from pressuremeter testing modulus and limit pressure obtained from pressuremeter testing.

The results of pressuremeter tests are presented in Figure 5. The change of limit pressure and deformation modulus before and after improvement are shown in the figure. The increase in limit pressure is a measure of the increase in shear strength and the bearing capacity and the increase in the deformation modulus is a measure of decrease in the subsoil compressibility.

Therefore, safety of the structure during implementation of remedial measures has been satisfied with the integrated approach of instrumentation and monitoring during application, and it has been possible to justify and implement an engineering solution by monitoring the efficiency of the soil improvement. Both the results of the displacement monitoring and pressuremeter testing indicate that the mechanism that results in structural cracks have been eliminated.
