Preliminary Findings from an Investigation of Improved Ground Performance During the 1999 Turkey Earthquakes

James R. Martin II¹, C. Guney Olgun¹, James K. Mitchell¹,
H. Turan Durgunoglu², Canan Emrem³

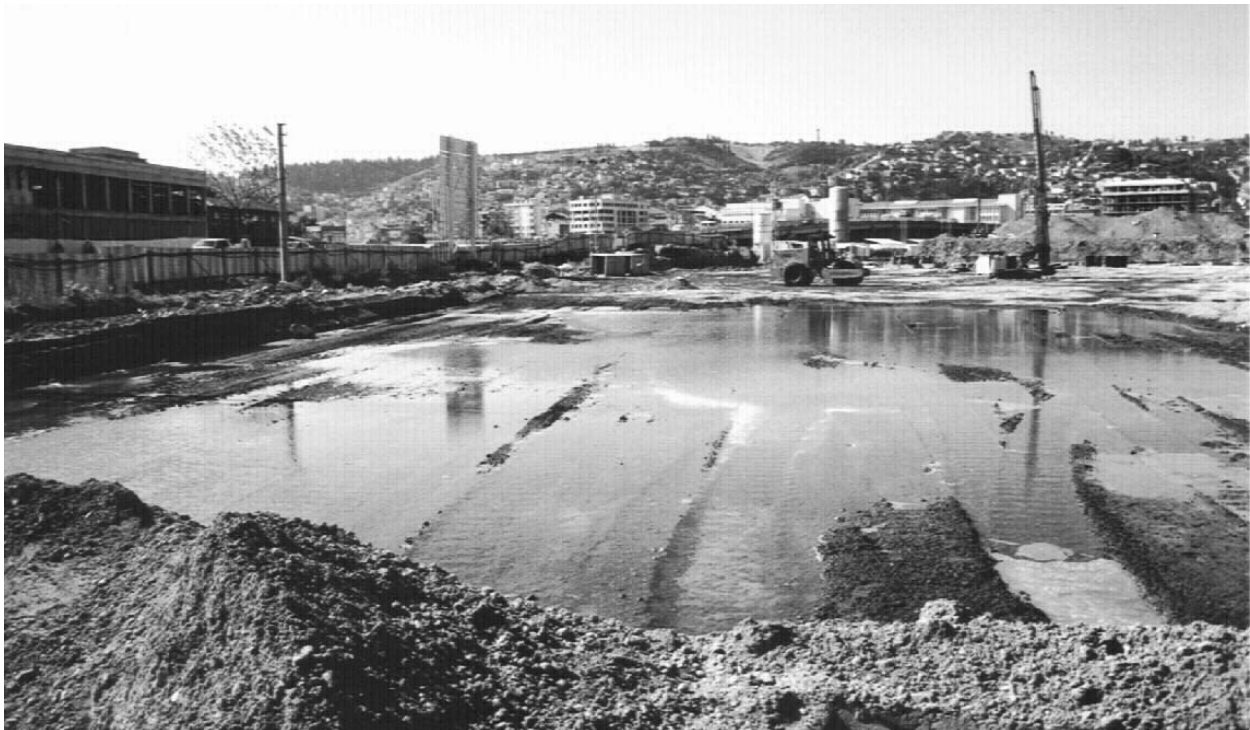
Site personnel reported that the untreated portion of the Parking Structure area was inundated with about 7 to 10 cm of water that temporarily ponded on the ground surface the morning following the earthquake as shown in Figure 3. It may be remembered that wick drains were installed in this area, and a surcharge fill was removed prior to the earthquake. Field inspections determined that the water originated from the underlying soil deposit via drainage through the wicks. It is fortuitous that settlement-measuring devices were in place at Lot C during the earthquake. By comparing pre- and post-earthquake readings from within the soil profile, the earthquake-induced settlement of the sand layer could be closely estimated. It was found that 8.0 cm of settlement occurred in the 2 m-thick loose silty-sand layer, presumably due to pore pressure build-up and subsequent reconsolidation via drainage through the wicks. It is also possible that the wick drains provided partial drainage during the earthquake, although the silty sand is not expected to be free-draining. To our knowledge, this type of earthquake-induced settlement measurement is unprecedented and provides an opportunity to better understand saturated sand behavior under strong ground shaking. Also, the measured settlement of 8.0 cm in the loose sand layer compares well with the 7 to 10 cm of water ponding on the surface, as the amount of extravasated water should be reflective of the volumetric strain induced in the sand layer. It is important to note that no surficial ground disruptions, such as sand boils, occurred at this location. The wick drains are thought to have prevented liquefaction and/or provided efficient drainage of the sand during reconsolidation, although significant settlements still occurred.

Figure 3. Ponding of water at portions of the parking structure area that were not yet treated with jet grout columns, Lot C under the preload fill is visible at the back – photograph taken the morning after the earthquake from the site border looking north

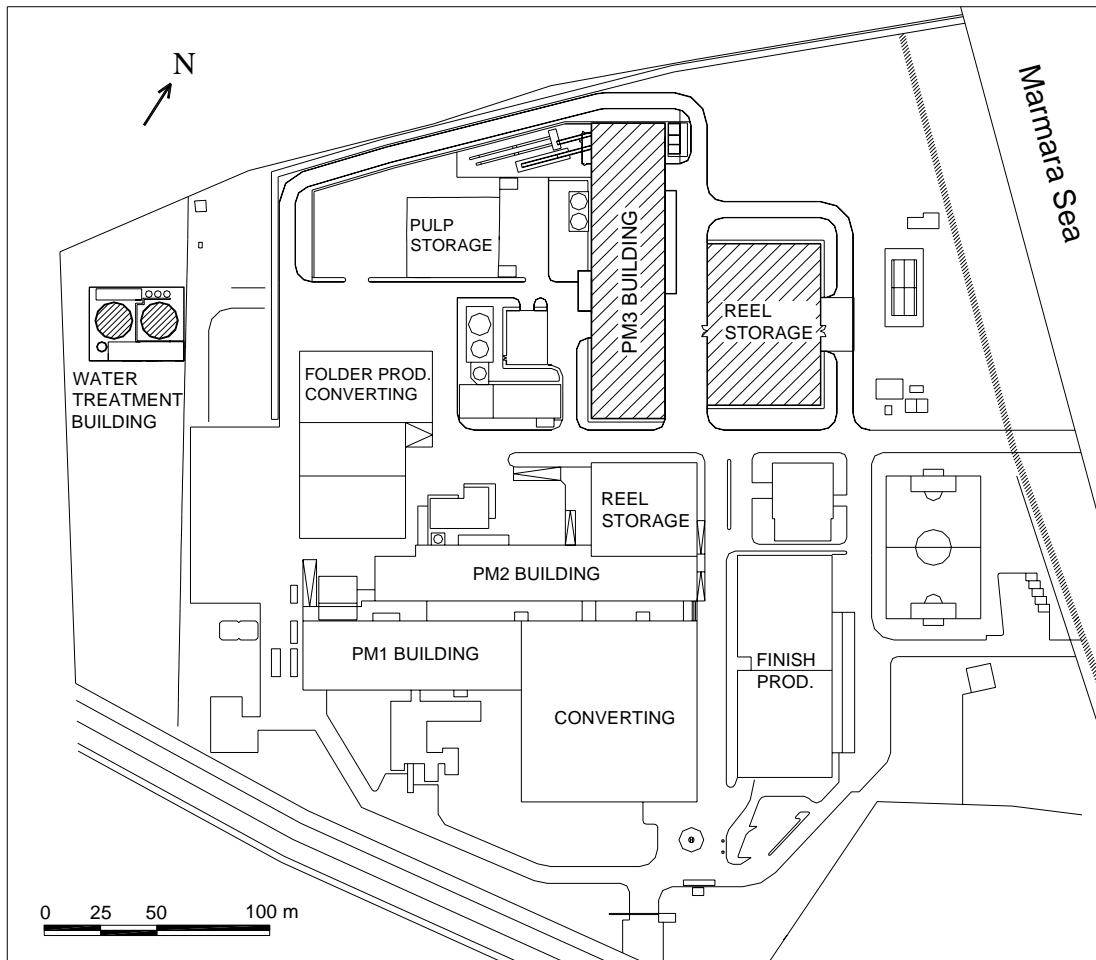
Figure 4. Ipekkagit tissue factory – site plan

Following the earthquake, a visual inspection of the plant revealed no major earthquake-related damages. All facilities remained operational during and after the earthquake. Only minor structural damage occurred in one of the older buildings (PM2 Building) where a heavy concrete facing element fell off the exterior of the building, and an interior reinforced-concrete column developed cracks about 1 cm-wide. No structural damage occurred anywhere else at the plant. The foundation soils for the PM2 building were not improved. Thus only structural damage occurred at an area where the foundation soils were not improved.

No signs of liquefaction or ground movements were found anywhere at the plant. Surprisingly, there were also no liquefaction-related features found along the northern waterfront or at neighboring sites, all of which contained untreated liquefiable soils. The lack of liquefaction-related ground evidence in these areas was unexplained (0.03g peak acceleration), and meant that effectiveness of the soil treatment for liquefaction mitigation could not be determined based on behavioral distinctions between treated and untreated ground.

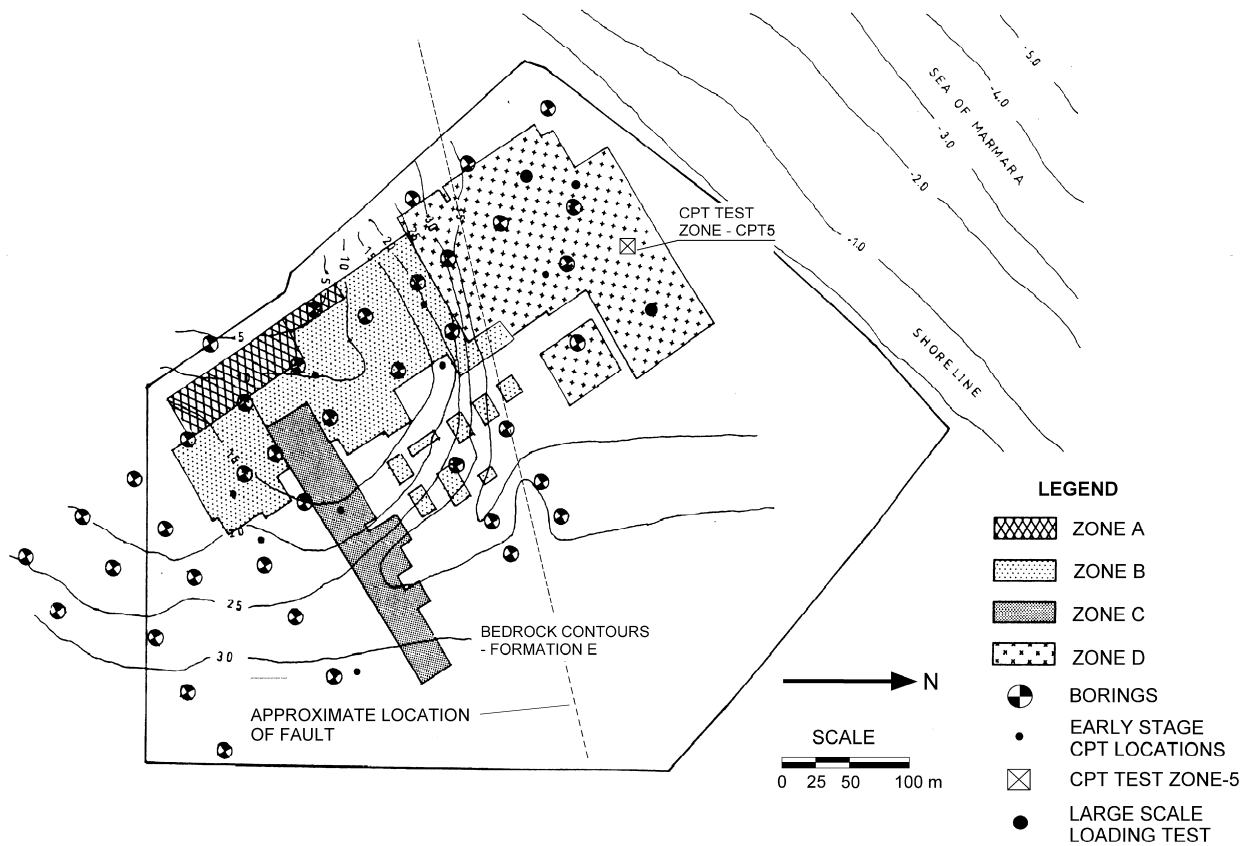
Figure 6. Borcelik steel mill – site plan

Following the Kocaeli Earthquake a visual inspection of the plant revealed no earthquake-related structural or ground damages. The ground shaking levels at the plant were relatively low, estimated in the range of 0.1g. The plant remained operational during and immediately following the earthquake. No cracks or signs of settlements were observed in the concrete floor slabs, and no ground cracks were observed anywhere across the site. Importantly, neighboring areas along the waterfront, including the port area of the plant that contained untreated liquefiable soils suffered no damages or obvious signs of ground movements. Further, other nearby industrial facilities in the Gemlik area reported either no or only minor damage. The relative lack of ground damage in the surrounding region, along with the relatively low ground shaking levels at the site, made difficult a more rigorous assessment of the effectiveness of the ground improvement.

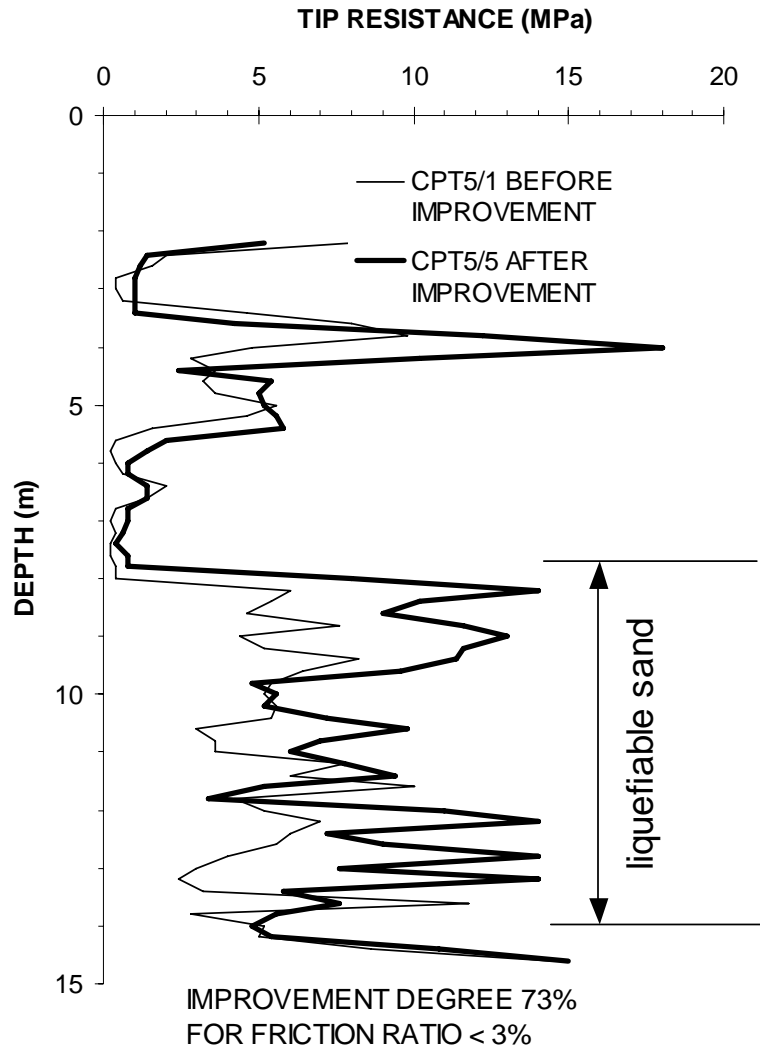
Figure 7. Typical CPT soundings before and after treatment

CPTs were also used during stone column construction to assess the degree of soil improvement for comparison with final design requirements. The area of stone column treatment was divided into sections, each having 200 to 400 stone columns. Six CPTs were performed in each section, with two performed before treatment, and four after treatment. It was found that the CPT tip resistances increased by about 75% in the sandy layers as a result of stone column construction. A typical pair of before and after CPT soundings is shown in Figure 7 (Durgunoglu et al. 1995).
