## Flexible Earth Retaining Structures - Soil Nailing

H. T. Durgunoğlu\*, H. F. Kulaç\*\* and C. G. Olgun\*

## FOUNDATION PROBLEMS OF KONYA ALAEDDIN MOSQUE AND IMPLICATION OF REMEDIAL MEASURES

H.T. Durgunoğlu(1), T. Karadayılar(2), C. G. Olgun(1)  
(1) Boğaziçi University, Civil Engineering Department, İstanbul, Turkey  
(2) Zetas, Earth Technology Corp., İstanbul, Turkey

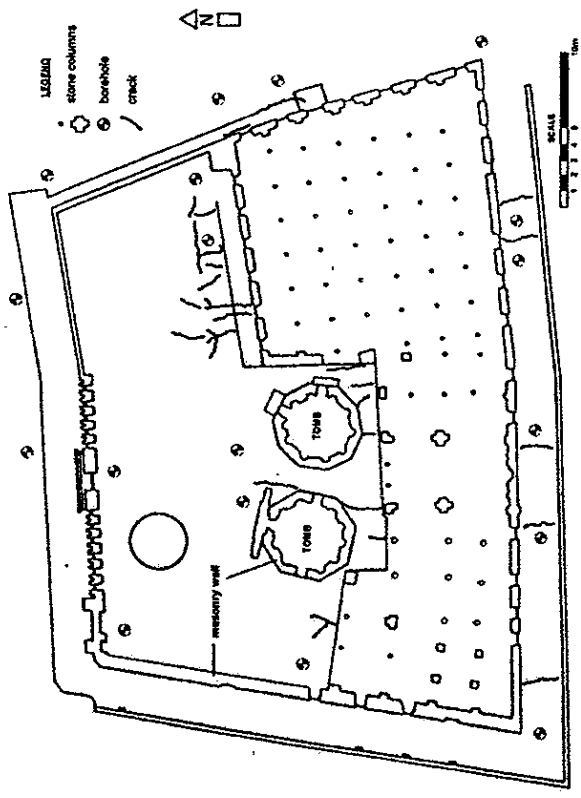
Figure 1. Konya Alaeddin Mosque, location of structural elements

problem, the situation became worse and the damage in the structural system has expanded to the other parts of the structure due to improper recognition of the cause of problem at early stages. Especially in the last 25-30 years, elements of the structural system have been subjected to severe cracks and distortions. Various investigators have agreed that this was a result of deformations and settlements in the subsoil. Although several remedial measures including structural reinforcement of the foundations and ceiling have been conducted during the period of 1967-1972, the problems related with the structural elements have not been overcome. Finally in the past with accelerating crack propagation and structural damage, to avoid any structural collapse, the structural elements have been supported with a frame system and the mosque has been closed to the public.

It has been determined from the evaluation of performed subsoil investigations and study of crack locations that the foundation of the structure has been subjected to differential settlements. The foundation subsoil has been observed to be highly decomposed due to leakage from the water reservoir located below the southern face and eastern corner of the mosque, which has been used for long years as municipal water storage. Finite element analysis has been performed to evaluate and model the deformation pattern expected to occur within the subsoil located below the mosque. The settlement mechanism and the resulting crack pattern along the northwest-southeast wall are shown in Figure 2.

structural damage as a result of leaching with water. Remedial design has involved the implementation of cement grout for subsoil improvement and micro piles beneath the structural columns and walls. The behavior of the structure has been monitored during implementation by means of instrumentation.

Furthermore, following the identification of the problem, trial cement groutings have been performed for the choice of proper soil improvement method, and it has been observed that cement-water mixture grouting could be properly utilized for soil improvement purposes, without causing any further damage to structural members [2]. Finally the remedial project consisting of subsoil grouting and micro-pile construction beneath load carrying walls and columns has been implemented.
